# **Technical Bulletin**

## Overcoming when an ATTO Thunderbolt<sup>™</sup> adapter may become non-responsive

### January 2020

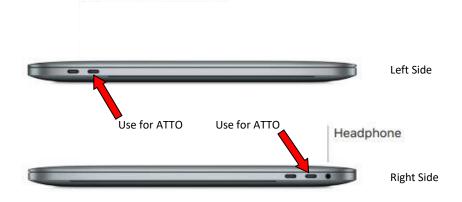
MacBook Pro 15in 2016						
Thunderbolt Bus 0 Thunderbolt Bus 1		bolt Bus 1				
Left Side Back Port	Left Side Front Port	<b>Right Side Front Port</b>	<b>Right Side Back Port</b>			
Route String 3	Route String 1	Route String 3	Route String 1			
3rd Party Vendor	ATTO	3rd Party Vendor	ATTO

Macs that have two Thunderbolt ports use a single chip that is split into Route String 1 and Route String 3. Macs that have four Thunderbolt ports use two chips, each having a Route String 1 and Route String 3. Please refer to the drawings below to identify the proper port for connecting ATTO products.
